INDIAN MOUNTAIN LAKE DAM

NDI ID NO. PA-00783  
DER ID NO. 45-227

PHASE I INSPECTION REPORT  
NATIONAL DAM INSPECTION PROGRAM

JANUARY 1980

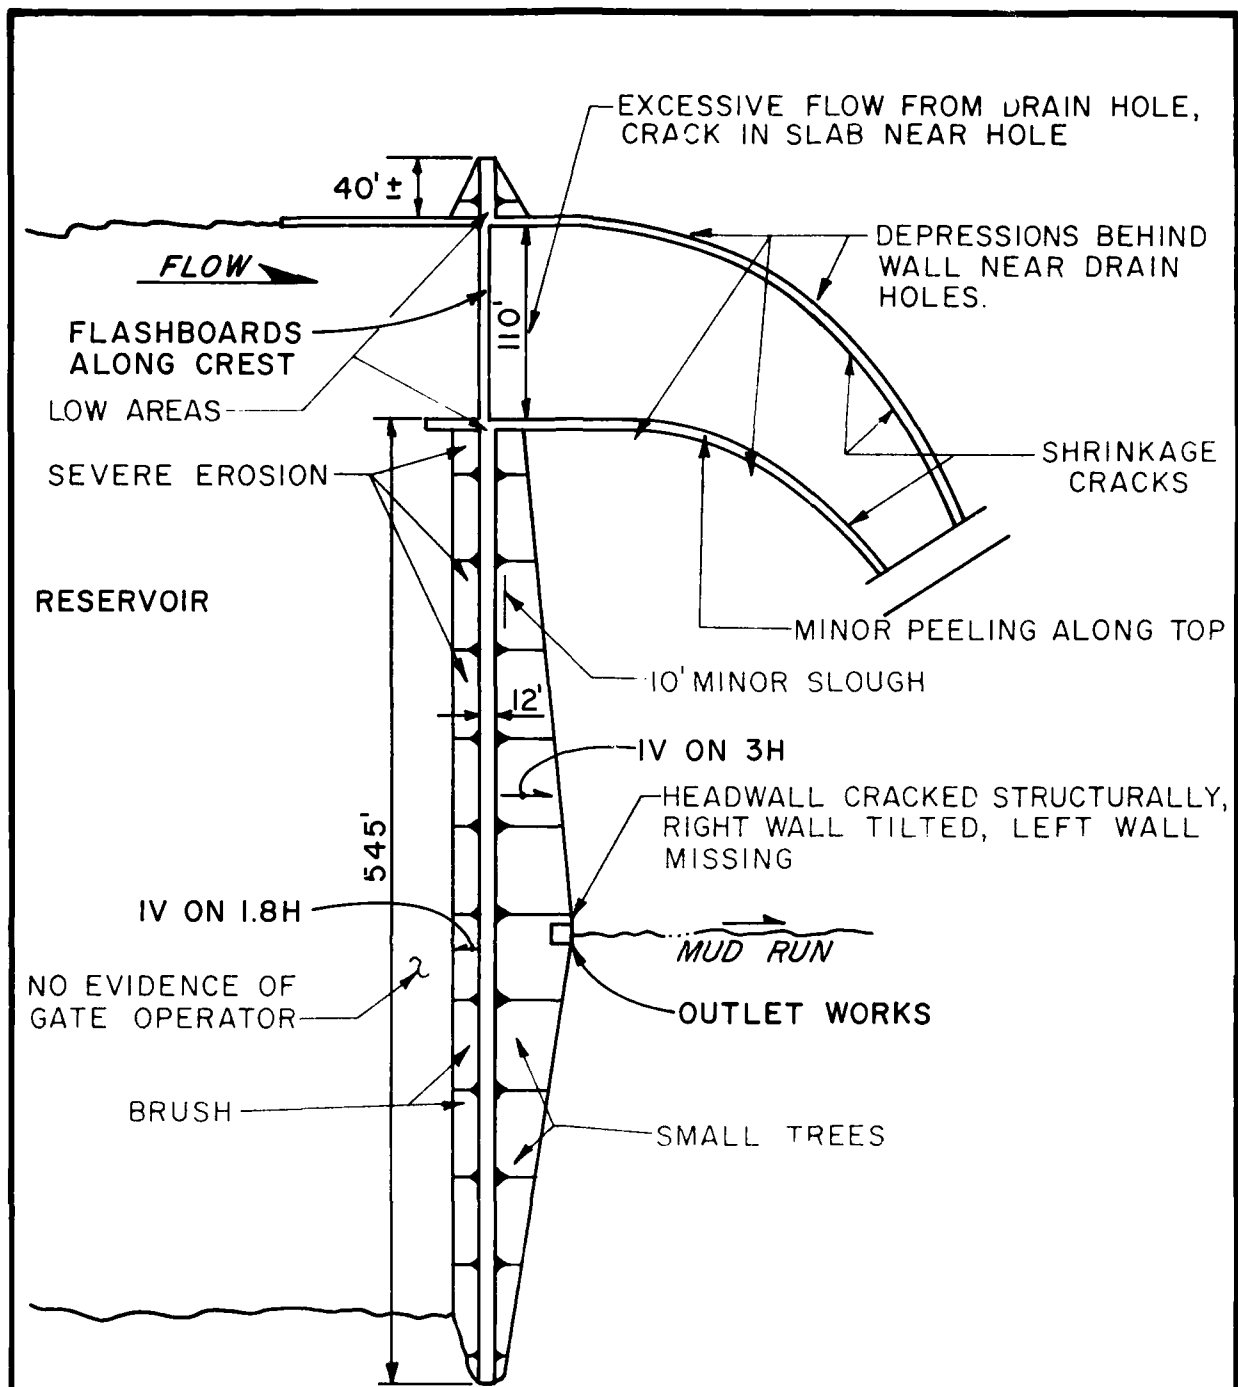
PHASE I INSPECTION REPORT  
NATIONAL DAM INSPECTION PROGRAM  
INDIAN MOUNTAIN LAKE DAM  
INDIAN MOUNTAIN LAKES CIVIC ASSOC.  
**RESULTS OF  
VISUAL INSPECTION**

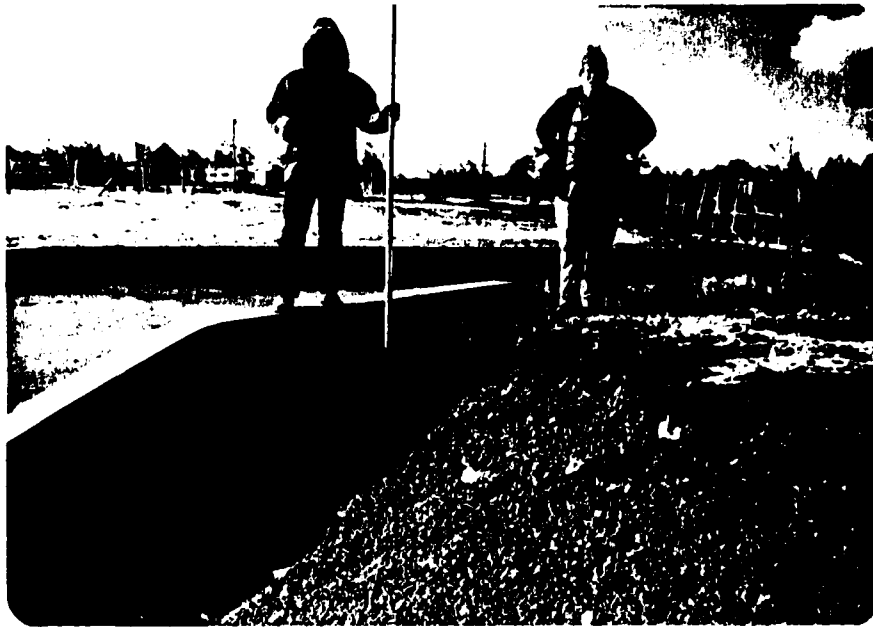
E. Upstream Slope Near Spillway

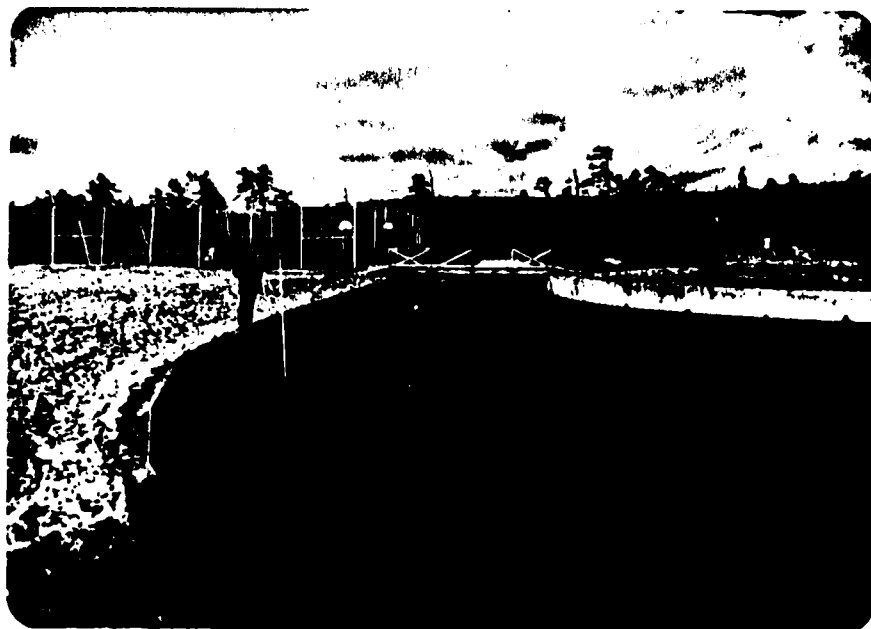
G. Spillway Outlet Channel

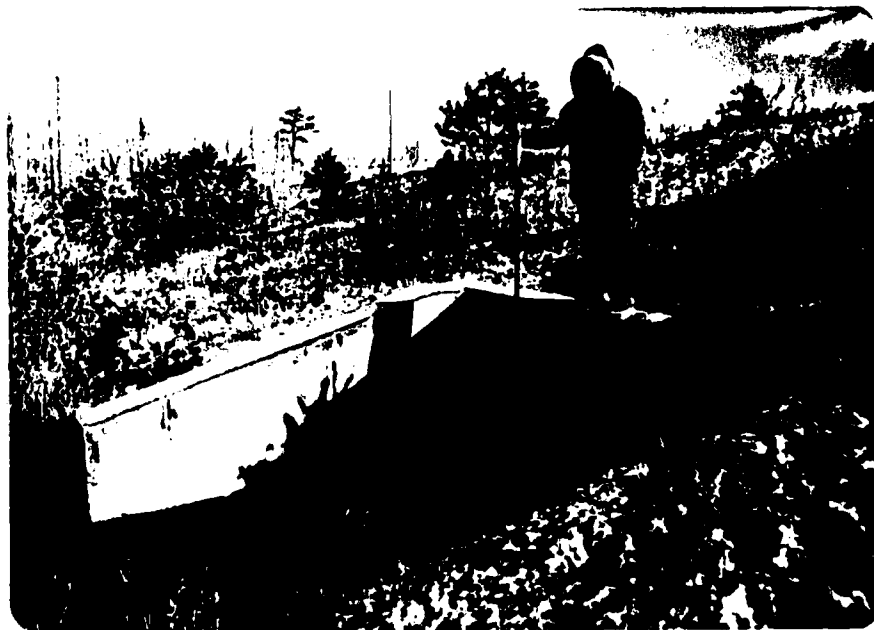
The outlet works is in poor condition. Although available drawings indicate that the outlet works has a gate, no evidence of the gate operating mechanism was observed. The Owner's maintenance supervisor believed it was submerged, but said that he had never seen it. No deficiencies were observed at the steel conduit. The outlet works structure has failed structurally. The left sidewall has been removed and is lying about 30 feet downstream on the overbank of Mud Run. The right sidewall is tilted and separated from the headwall (Photographs I and J). There are structural cracks in the headwall (Photograph J).

Conditions at the outlet works are of concern. The lack of a gate operating mechanism is evaluated in Section 5. The outlet structure has failed structurally. The sidewalls (Photograph J) do not appear to have been constructed in accordance with the design drawings shown on Plate E-3. The increased load on the headwall, which was caused by the 1962 modification to the dam, is the probable cause of cracking. The entire headwall and sidewalls are unable to support the loads placed against them.

J. Outlet Works Headwall
